## Flowchart; floor-surface examination for JK ® system.

## Floor Surface Illustrations [black, sticky, bitumen, tar, adhesive]

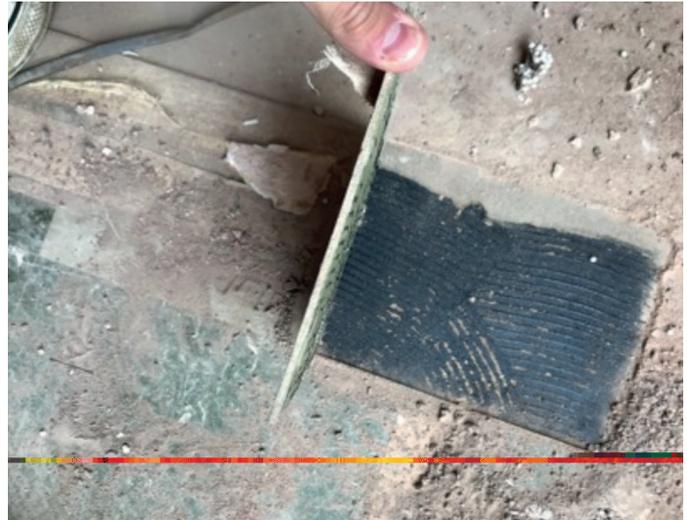
**Figure 2.1.** Sticky bitumen under ceramic tile

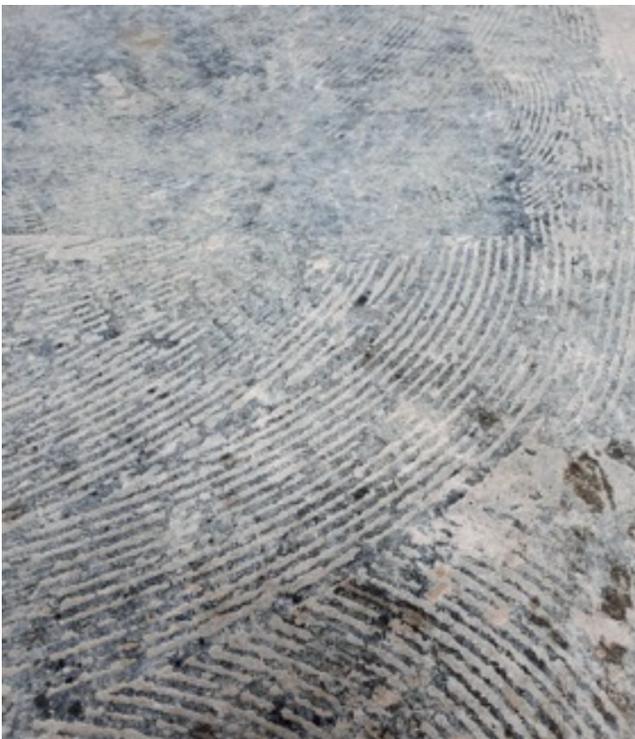
**Figure 3.** Black non-sticky floor after removal old floor-finish

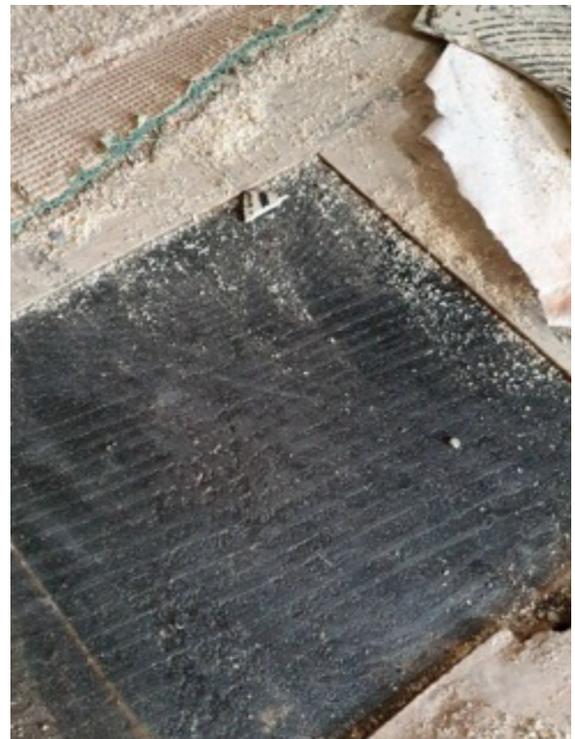
**Figure 2.2.** Sticky bitumen present

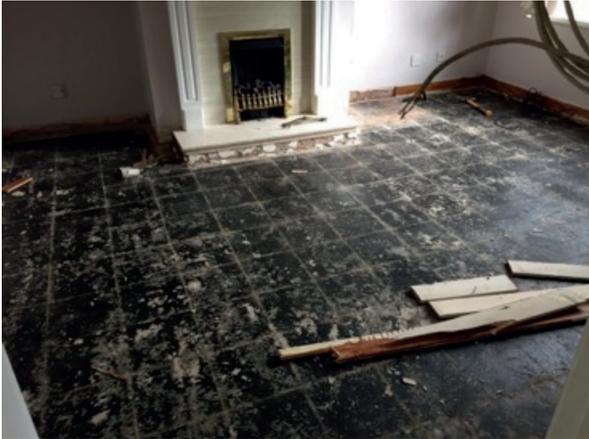
**Figure 4.** Black (sticky) floor after removal old floor-finish

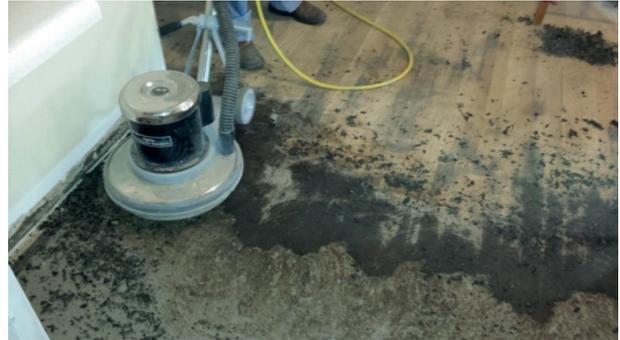
**Figure 5.** Floor-scabbler equipment designed for the purpose to prepare floor-surfaces. Removal of various remains, e.g.; adhesive, tar and bitumen.

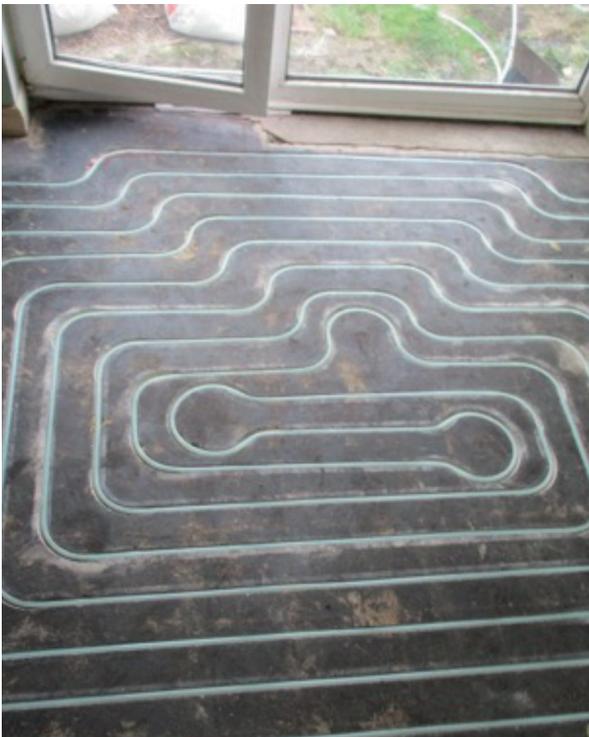
**Figure 8.** Negative asbestos result and non-sticky black surface can be cut with the JK floorgrinder to install the JK® system.

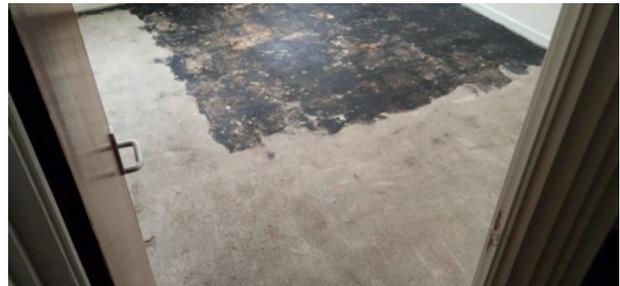
**Figure 6.** Result of floor partly prepared with floor-scabbler

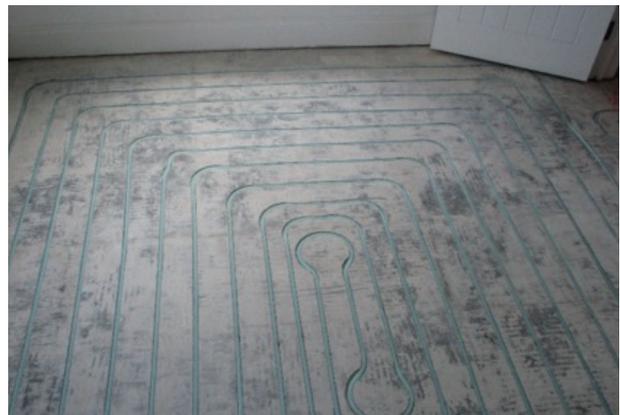
**Figure 7.** Fully prepared floor-surface with JK® system installed. (Concrete/Screed/Cementitious floor-surface; gray shaded)
